Purpose: CERCLA Screening Site Inspection

Site: Golden Eagle Refining Co., Inc.
21000 South Figueroa Street
Carson, California
Los Angeles County

FIT Investigators: Karen Johnson
Christine Houston
Rita Mundy

Date of Inspection: March 30, 1989

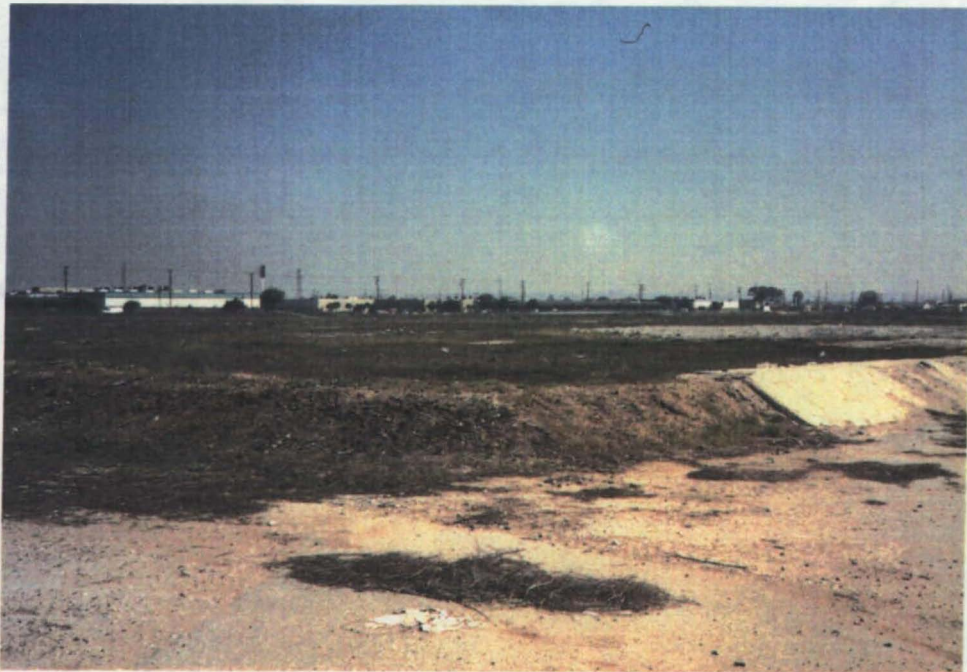
Old tank farm area - gravel pad center right. Berm has been scraped of asphalt liner - bioremediation took place inside bermed area

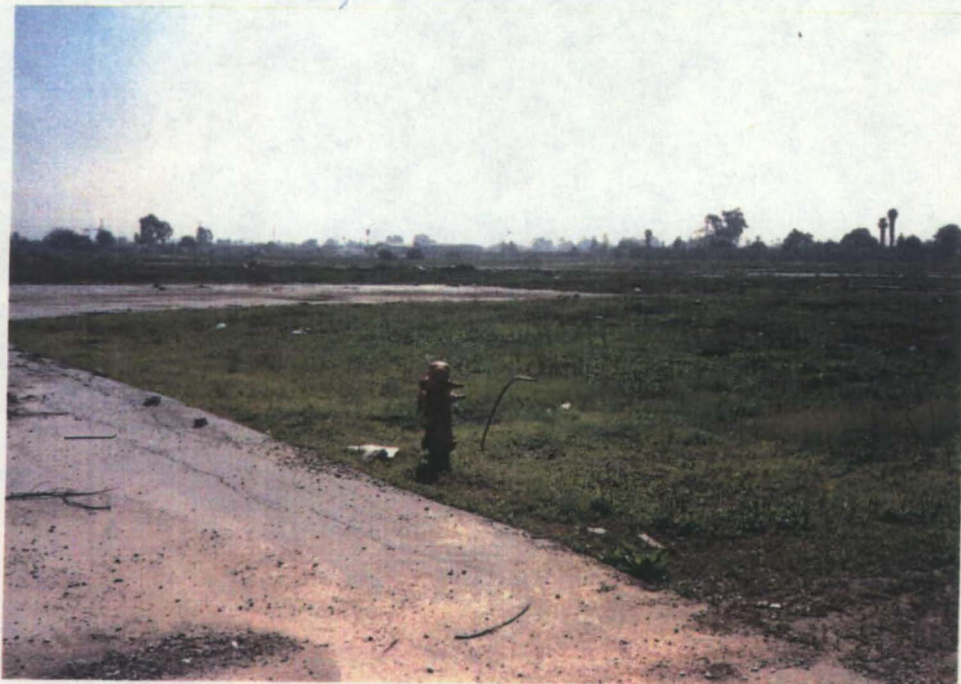
Refinery site in middle ground - land farm area in background. Homes just beyond bushes/fence upper right.
wp/kj/goldeagle/cr-srw-fpls

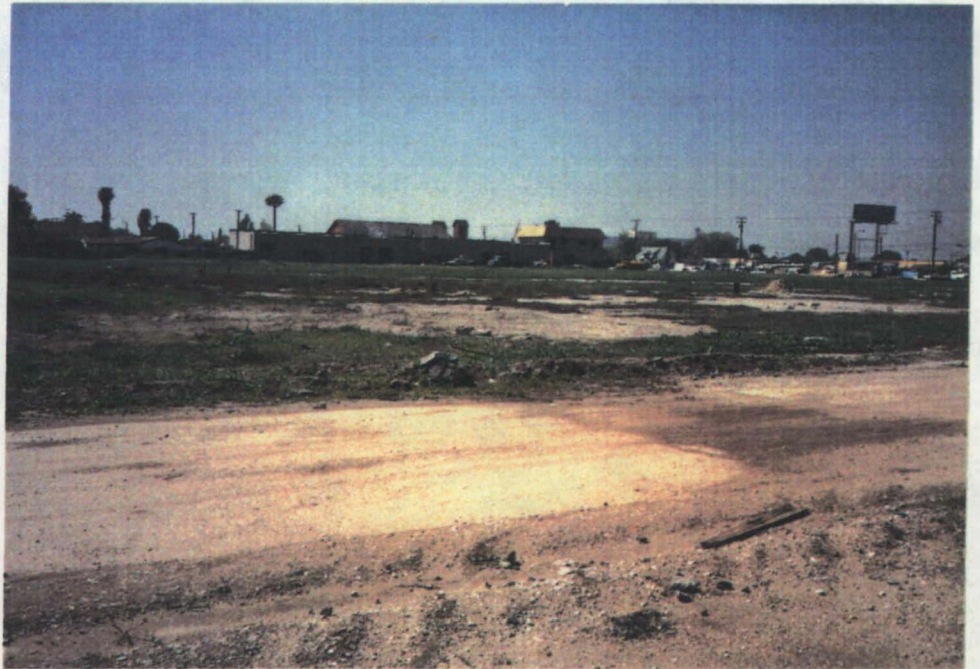
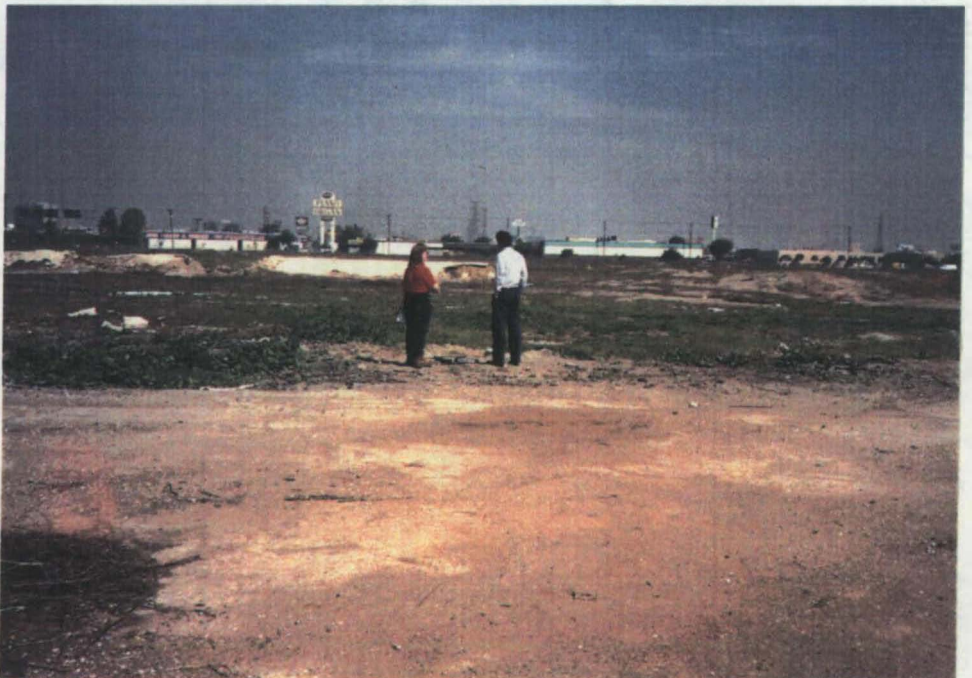
Standing at MW-8 at North end of building site. Waste oil tank sat to North.

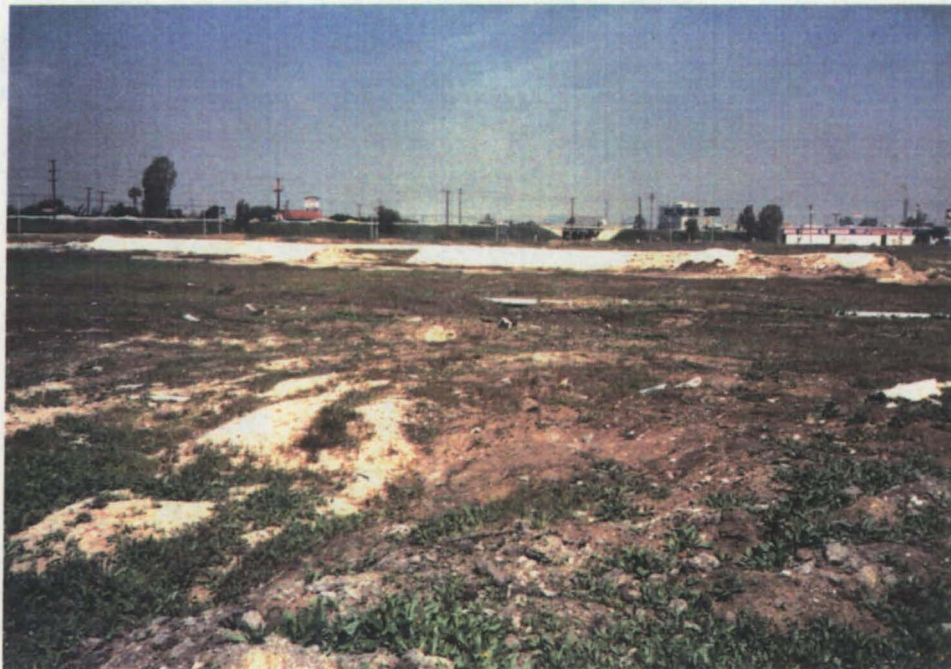
Partial berm of tank farm in background. Lower left is beginning of depression left from UST removal that was just west of building site.

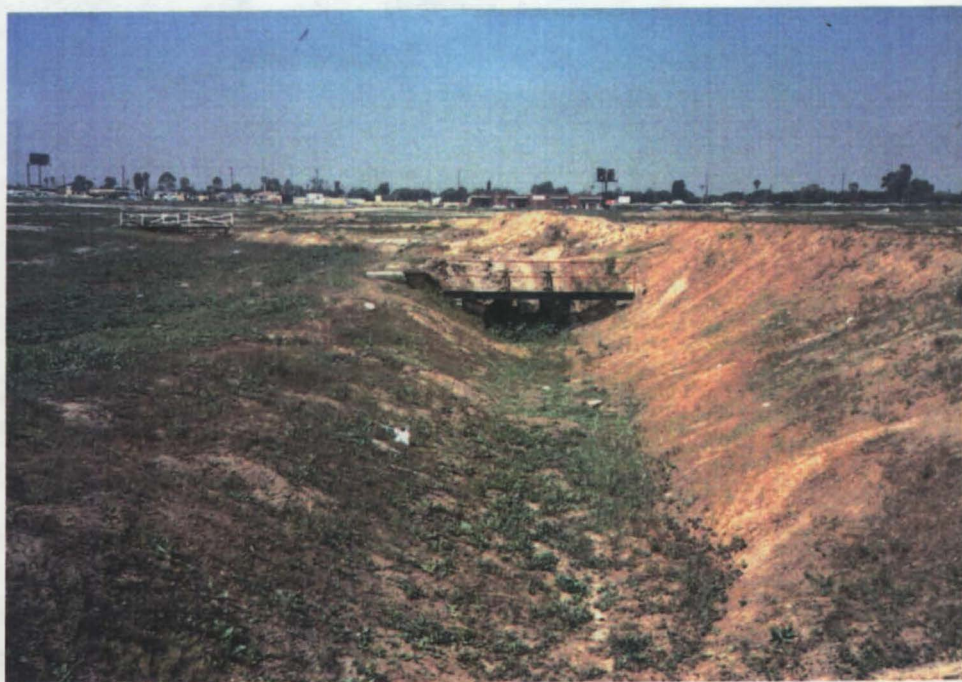
Drainage ditch - flow toward bottom - debris gate at upper left. Also had oil absorbent material that water passed through.

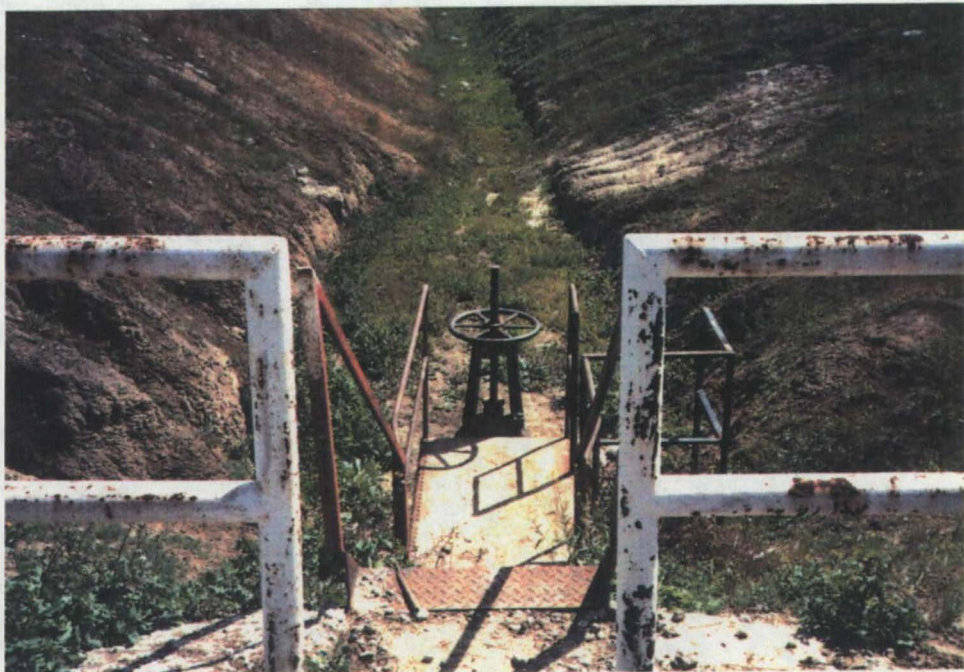
Valve to close drainage.

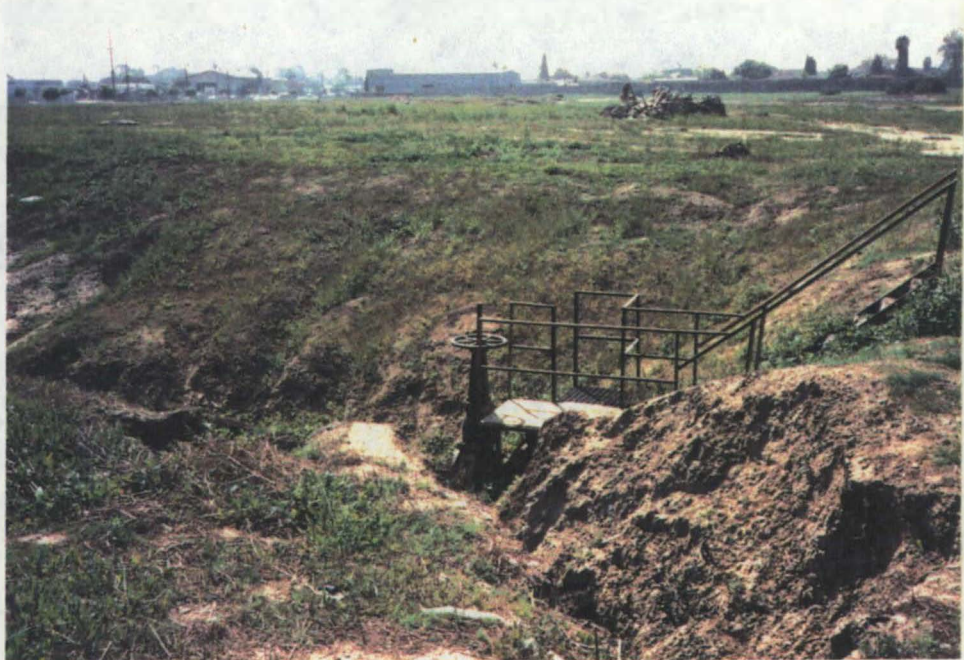
Drainage discharge valve - sampling location for NPDES compliance - bushes
upper right is approximate area that high Pb soil removed.
wp/kj/goldeagle/cr-srw-fpls

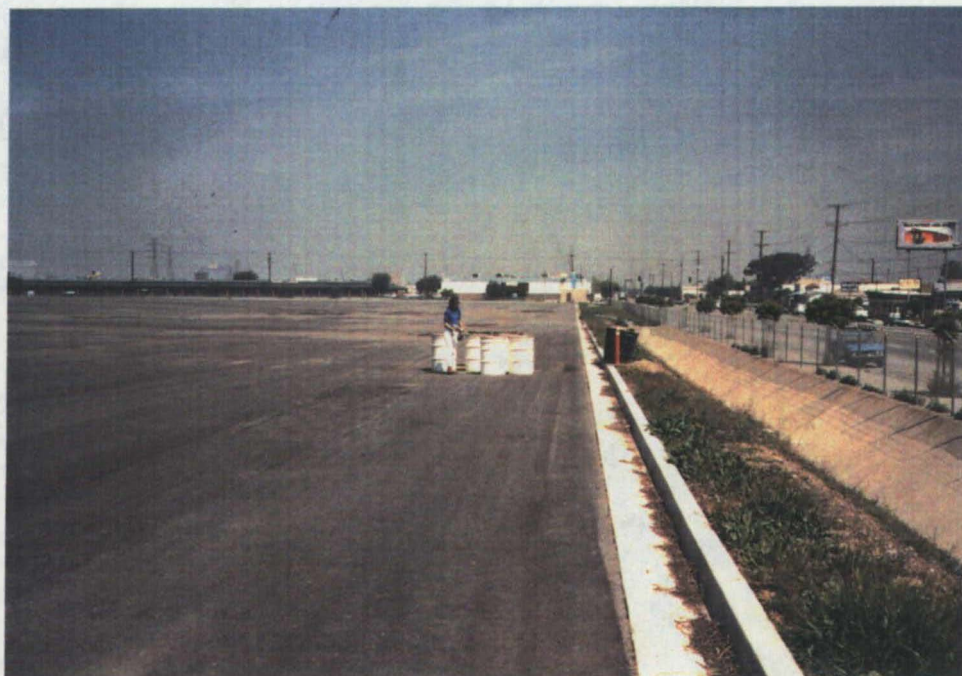
On right is concrete drainage ditch that parkign lot drains into thru drop in curb (at level of top of black drums).
wp/kj/goldeagle/cr-srw-fpls

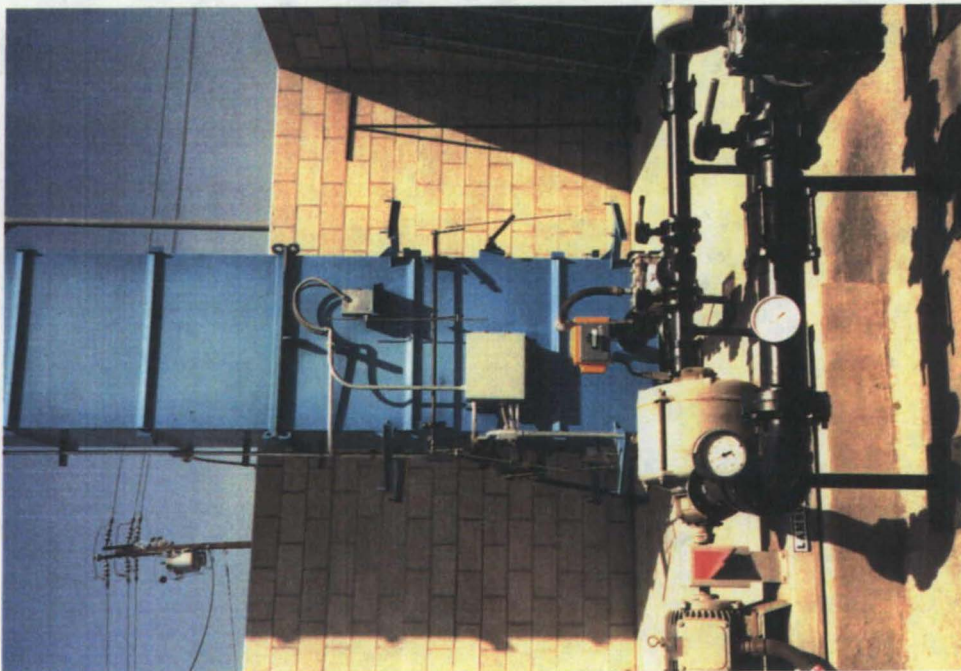
Inside landfill gas flaring station.

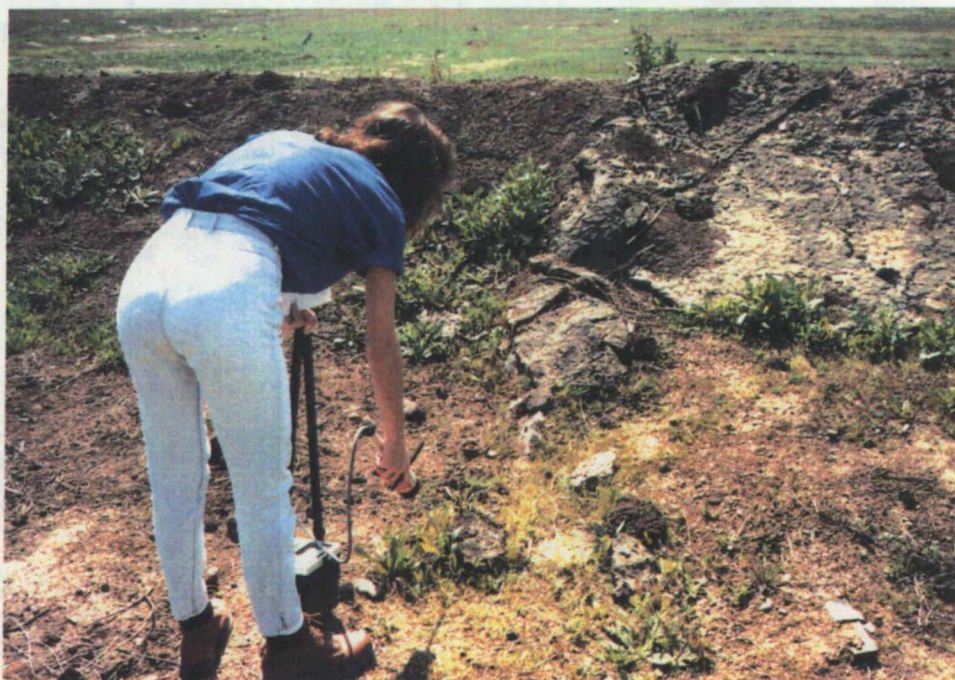
Rita taking HNu reading of asphalt. (read -0-) Asphalt was not degraded by bacteria and is still mixed in soil in old tank farm area. Long chain HCs are non-migratory and therefore not a real problem (per Epperson).
wp/kj/goldeagle/cr-srw-fpls
